**Subsidence Documentation Study**  
**Sufco Mine**  
**May 30, 2003**  
**Summary**

The data contained in this binder is a compilation of subsidence features gathered in the field from the 19 of May to the 22 of May 2003. The features have been organized into five different sections representing panels in descending order starting with the most recent. At the beginning of each section is a summary sheet outlining important aspects of the panel with emphasis on subsidence features contained therein.

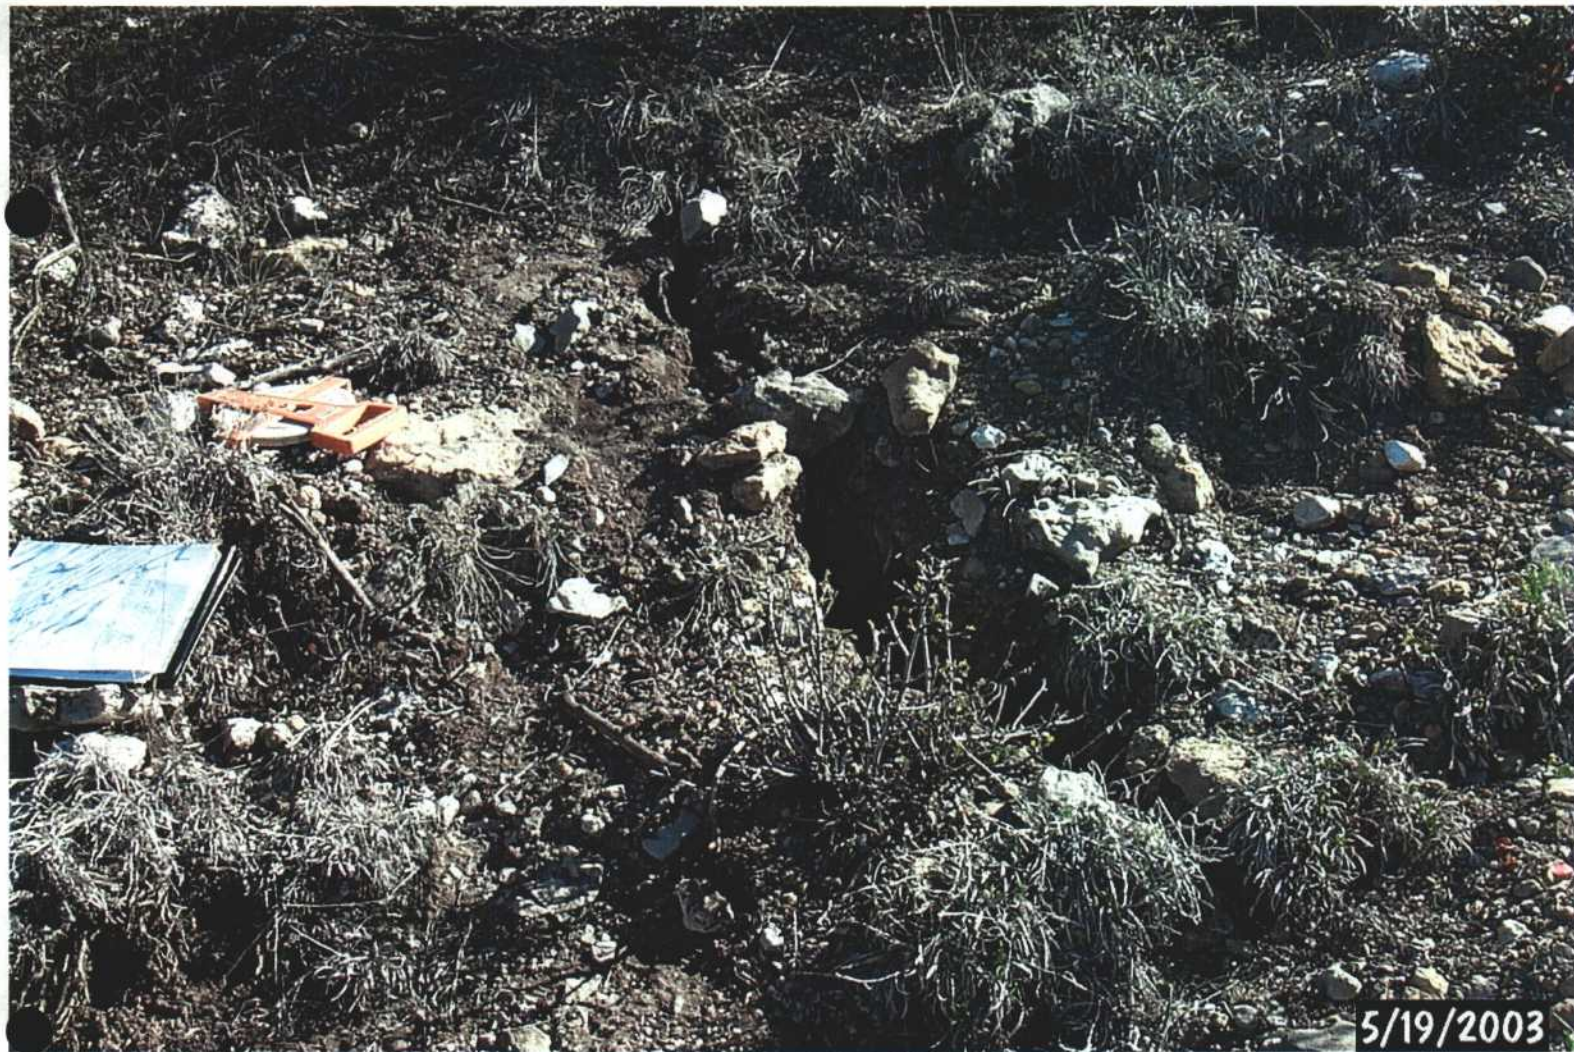
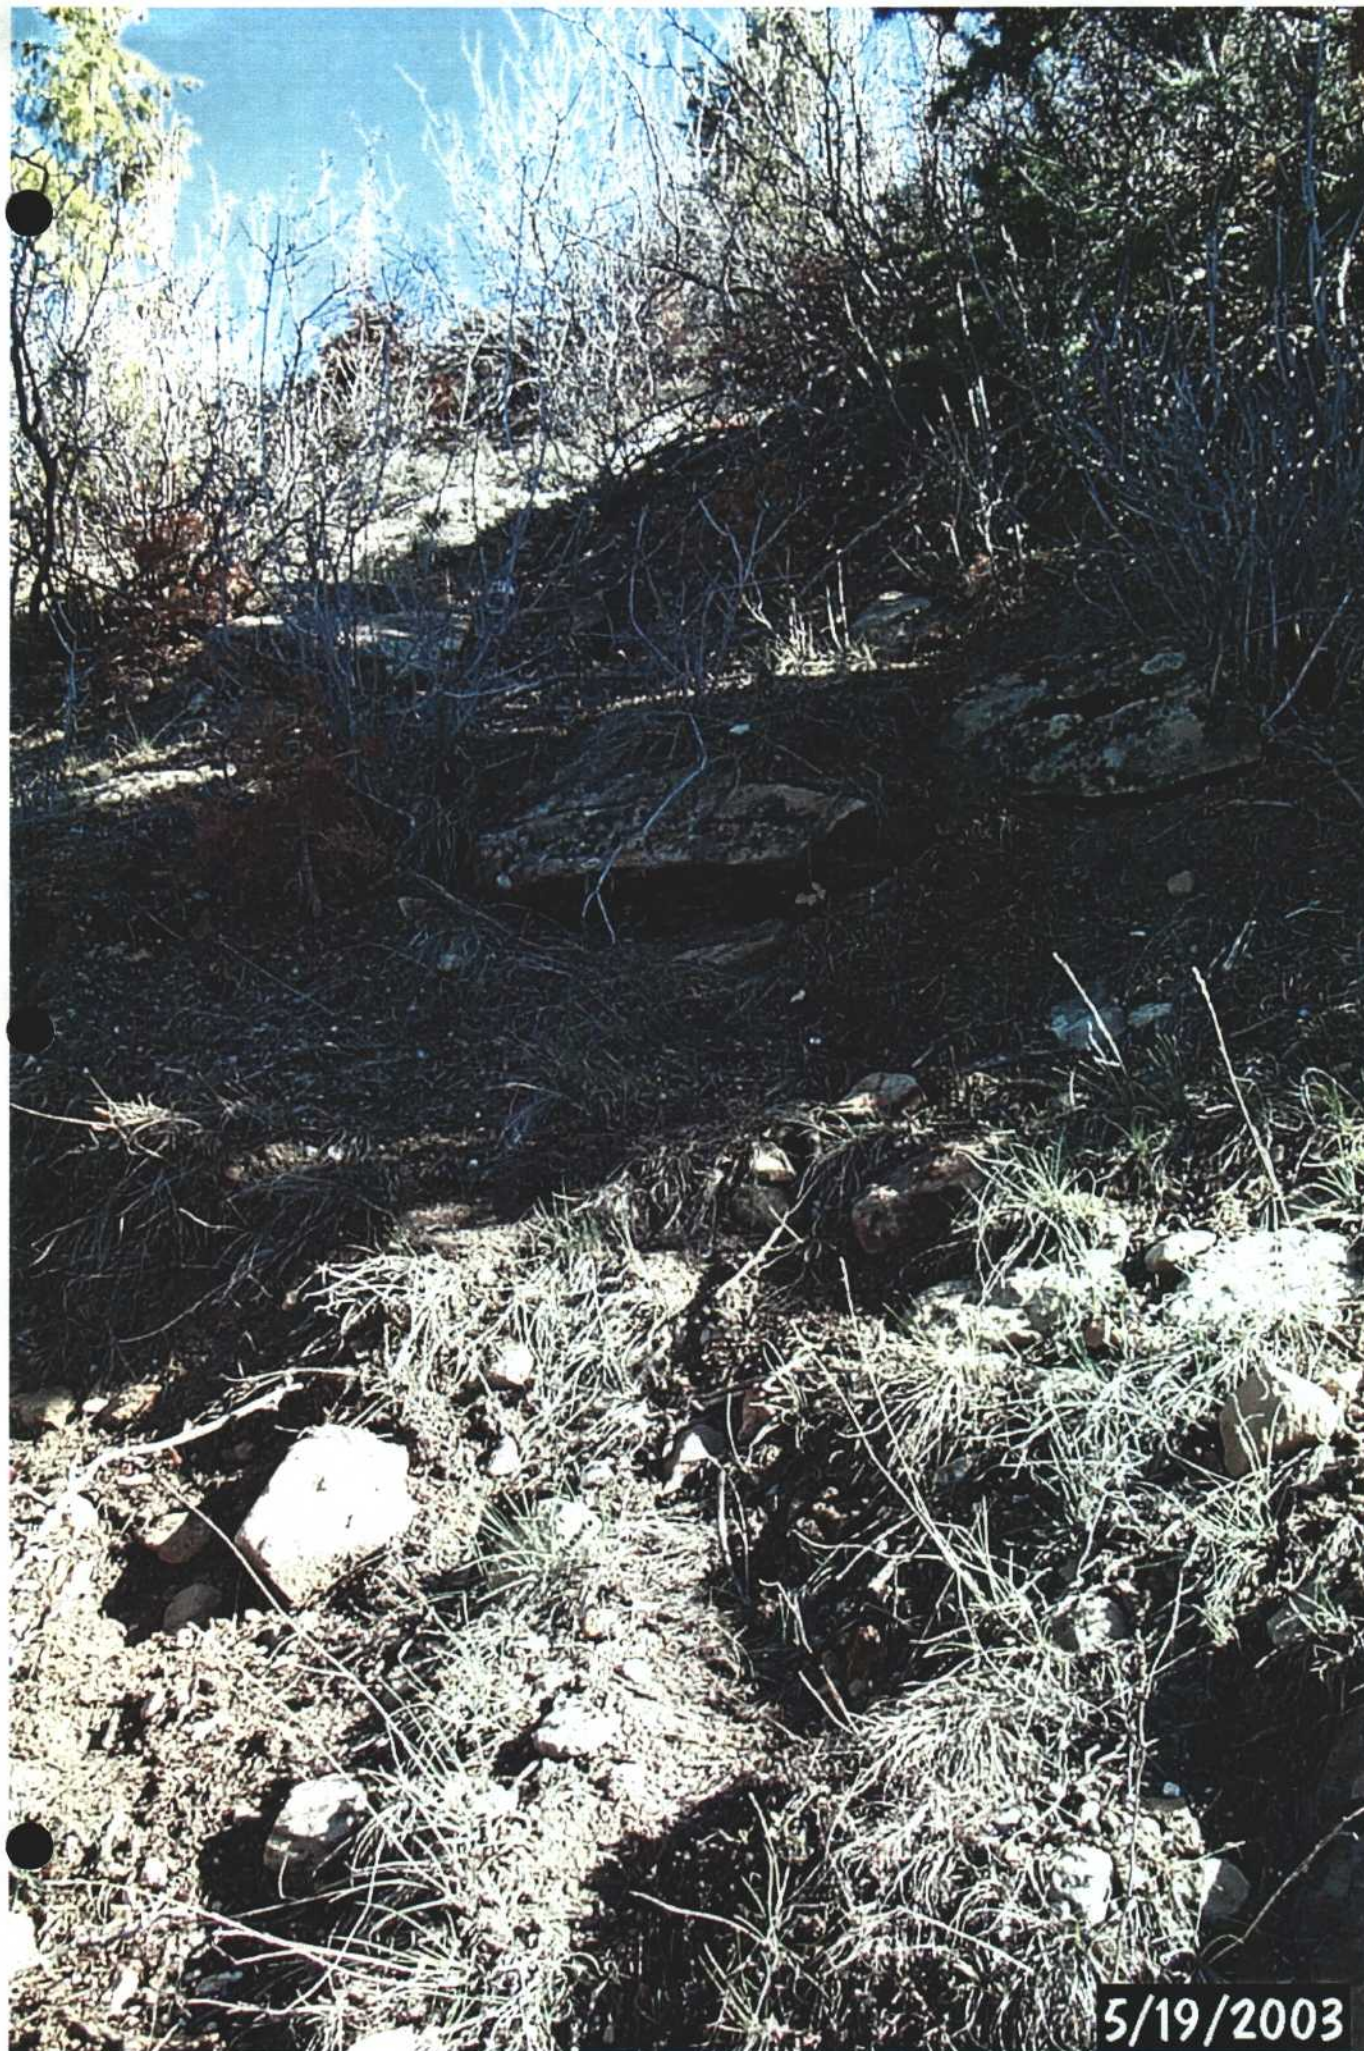
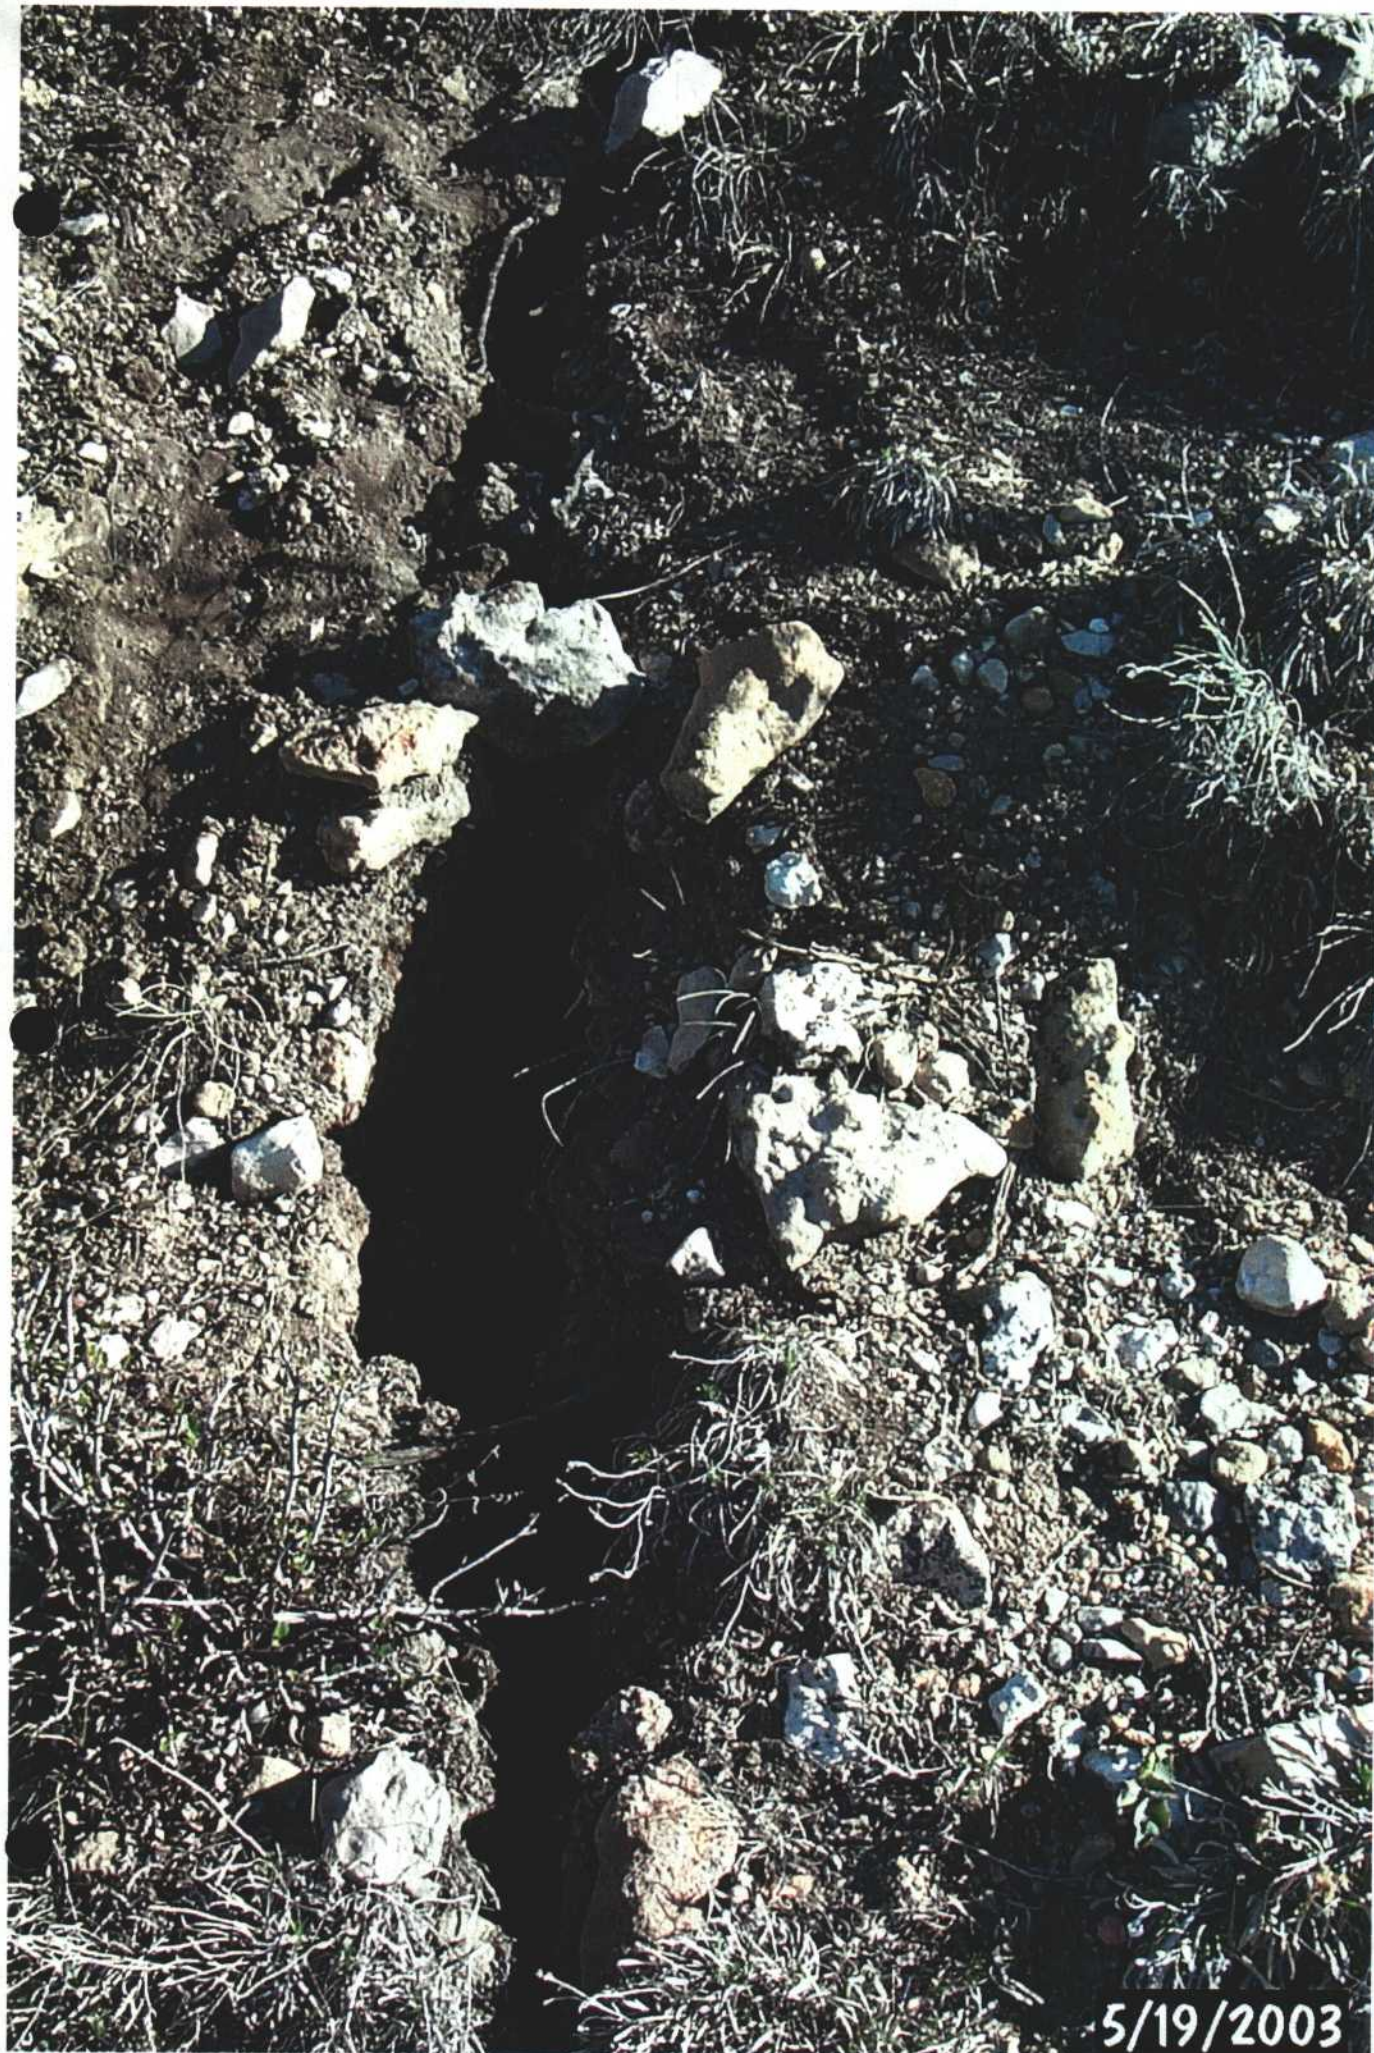
Panel: 1 left pines east Feature # 2

Dimensions (in feet): 54 feet long  
10 inches wide in places  
more than 4 feet deep in places

Potential Hazards? Crack is large & is wide enough to easily step into in places.

Seems to be healing in places but may need mitigation in the future.

Features 2, 4, and 7 should be watched and monitored at a later date to ensure that healing is underway and show no signs of worsening to the point of becoming a hazard.

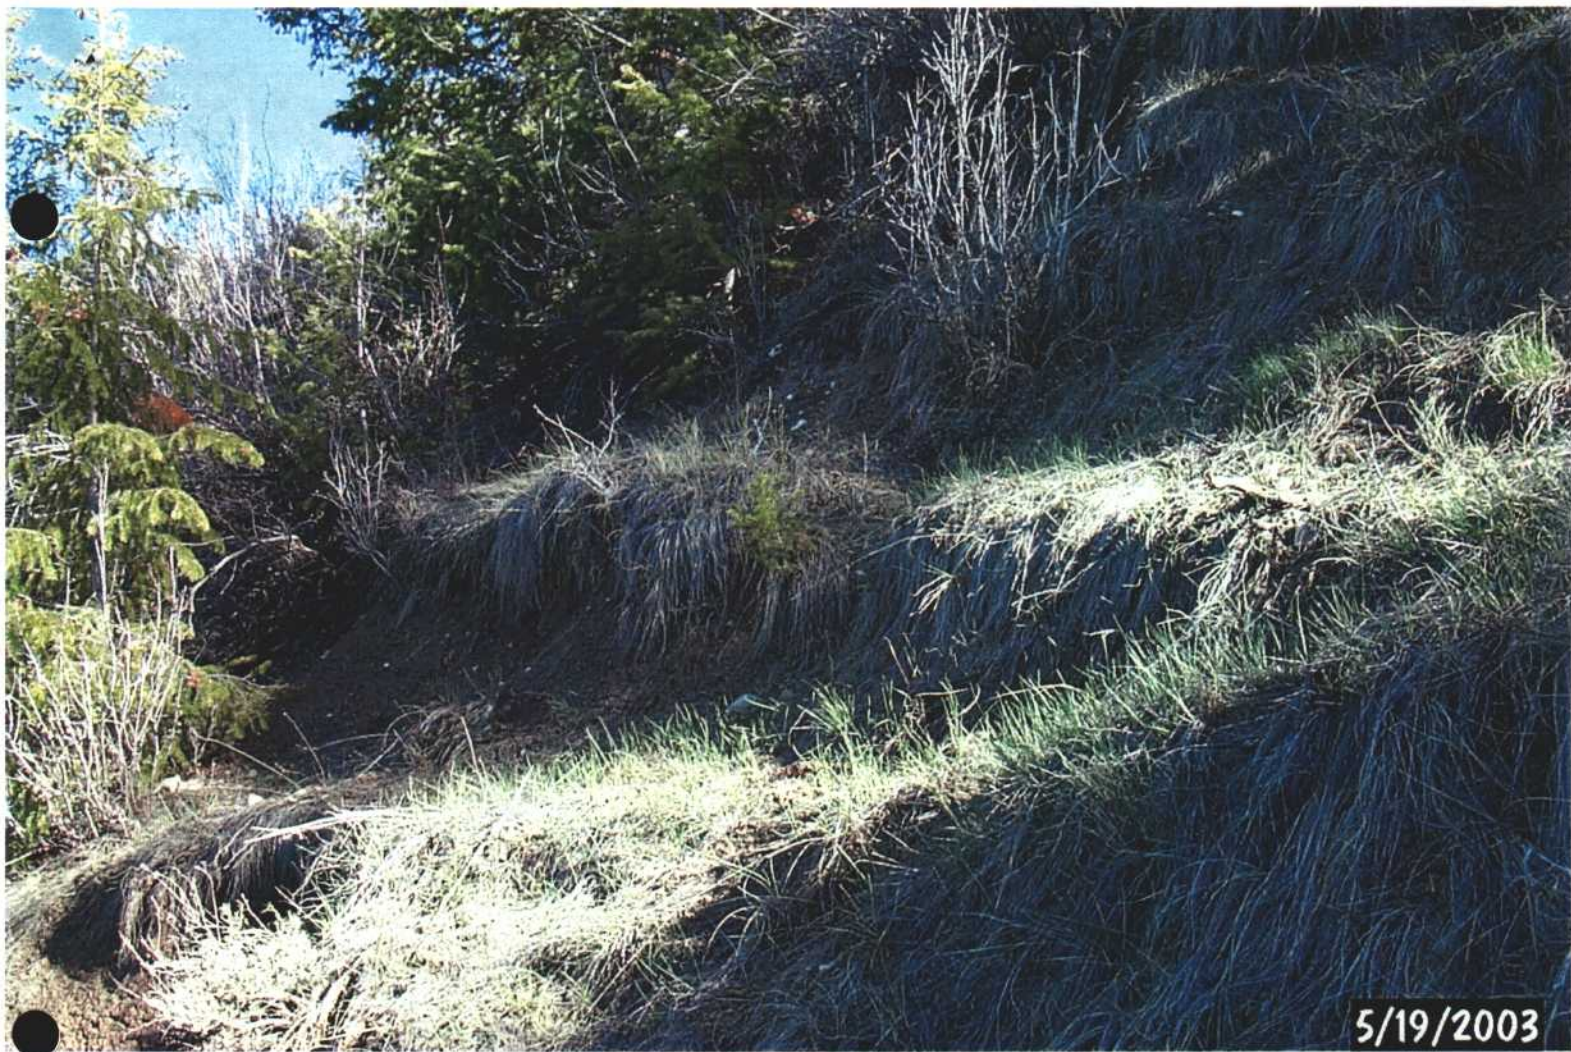
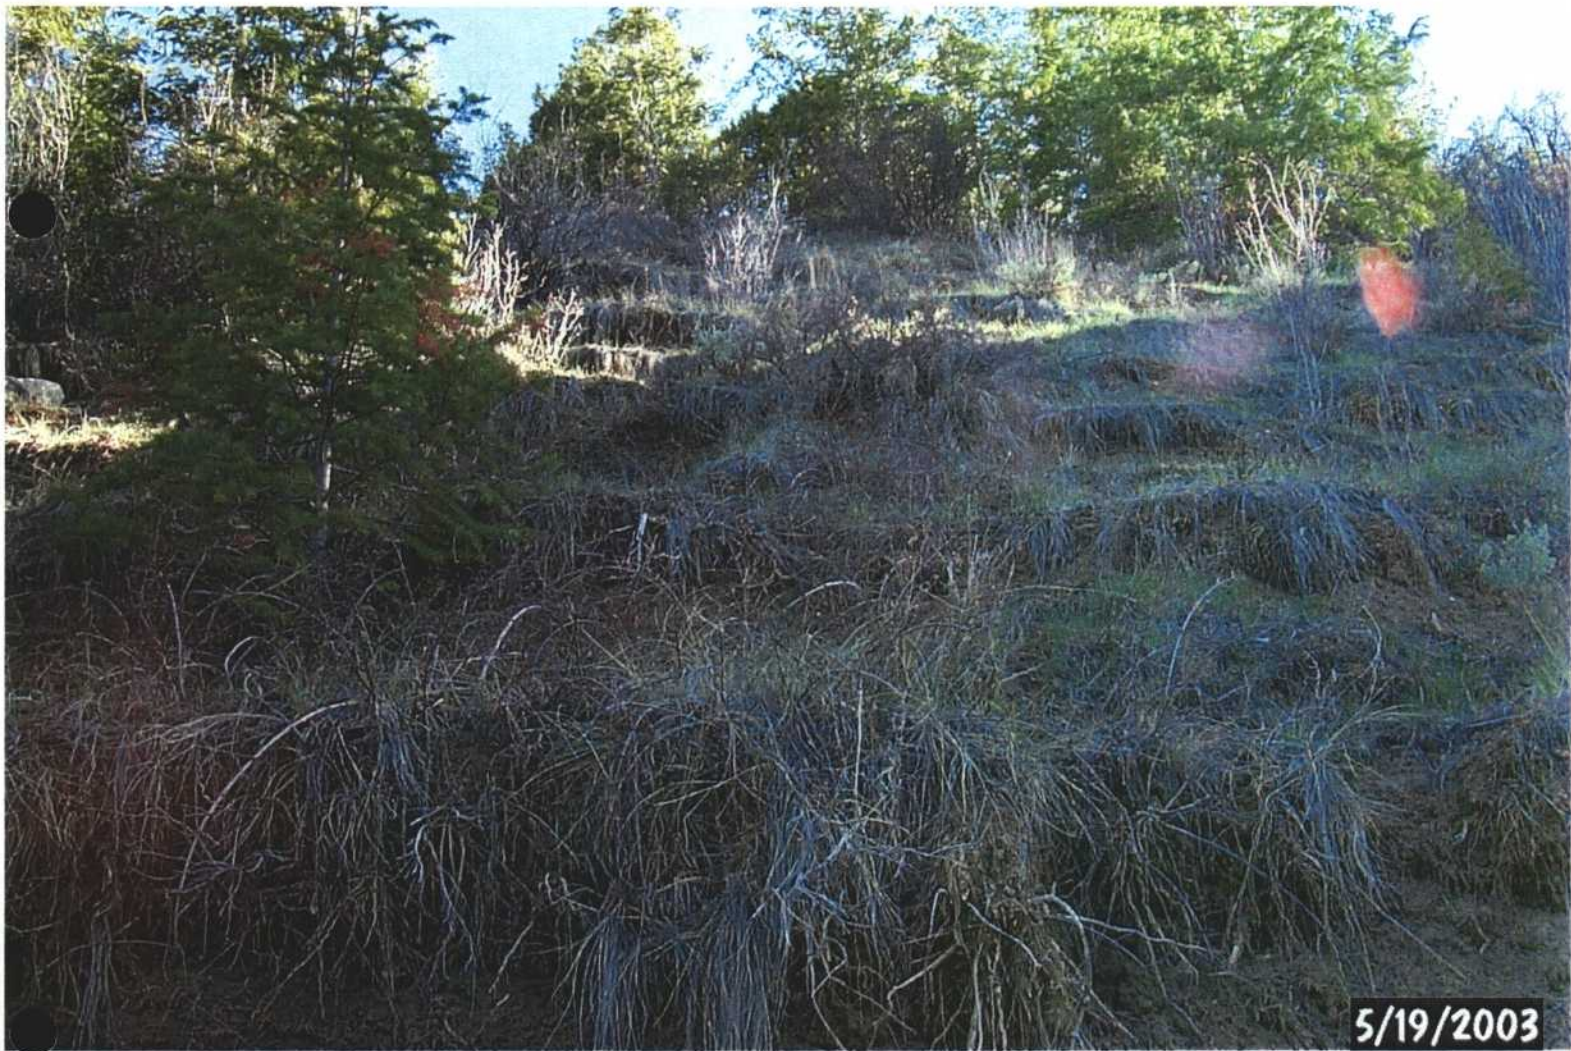
Panel: 1 left pines east Feature # 3

**Dimensions (in feet): Cracks form in parallel and then are displaced by as much as 4 feet of offset in a step-like formation. This stepping pattern covers a large swath of ground approximately 300 feet long by 250 feet wide.**

**Plants appear to be adapting well to the soil movement, & new grass is growing over displaced soil.**
